# STUDY OF BEHAVIOR OF GRILLAGES IN ELASTIC AND PLASTIC RANGES

## FINAL REPORT

Contract No. N00024-67-C-5356  
Project Serial No. S-F013 C3 01 Task 2050  
SwRI Project No. 03-2101-01

for  
Naval Ship Systems Command  
Department of the Navy  
Washington, D. C. 20360

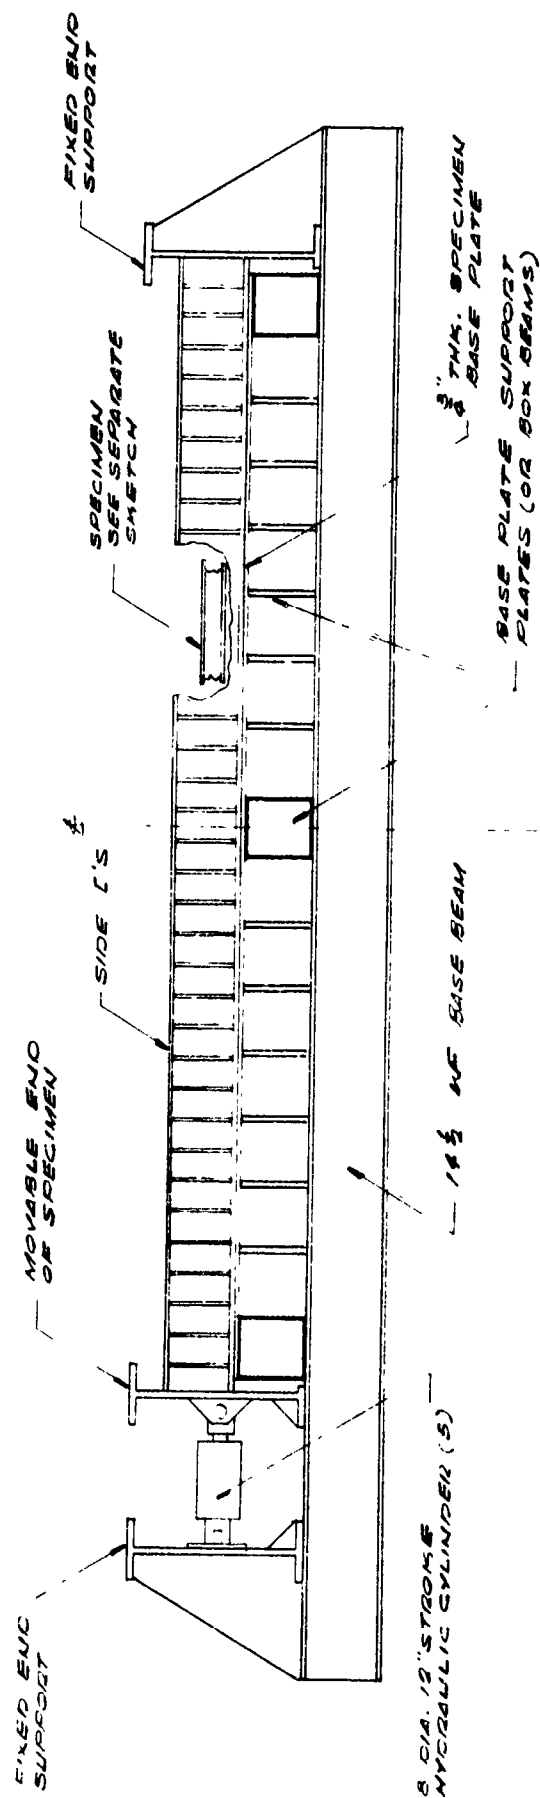
FIGURE 1. SKETCH OF THE GRILLAGE TEST FACILITY

The basic configuration of the test fixture is shown diagrammatically in Figure 1. The base of the fixture consists of eight -  $14 \times 14\frac{1}{2}$  inch wide flange beams (at 136 lbs/ft), 25 feet long. Over the region to be occupied by the grillage, there are ten -  $\frac{3}{4}$  inch plates 12 inches high; these are placed on edge and tack welded to the top flange of the base beams. A  $\frac{3}{4}$  inch plate 18 feet x 10 feet then lies above the 12 inch plates, thus forming the base for the specimen. A  $\frac{3}{16} \times 2\frac{1}{2}$  inch seal back-up strip is welded all along the periphery of the base plate, thus forming a seat for the grillage specimen and a cavity into which a fluid may be introduced for the purpose of producing normal pressure. A liquid tight seal is provided by a rectangular rubber section which bears against the seal back-up strip, Test 1(a), or, as was used during Tests 1(b) and 1(c), by a rubber bag lying between base plate and specimen.

The two ends of the fixture are closed by 30 inch I-beams, one of which is moveable and forms the end at which the axial compression is applied; the opposite end is fixed. The two longitudinal sides are closed by stiffened side channels which bolt through the specimen to the 3/4 inch base plate. Longitudinal motion is made possible by cutting 3 inch slots in the specimen, thereby allowing relative motions between the test grillage and the 3/4 inch base plate and side channels.

After the grillage specimen is placed inside the fixture, the entire top is covered by a 1-1/2 inch plate bolted with shoulder bolts to the top flanges of the 30 inch I-beams. This plate is sized to ensure that the axial load is reacted equally between base beams and cover plate. The axial load is applied by five 8 inch diameter hydraulic cylinders capable of exerting a total of about 1,500,000 pounds at a jack pressure of 6,000 psi.

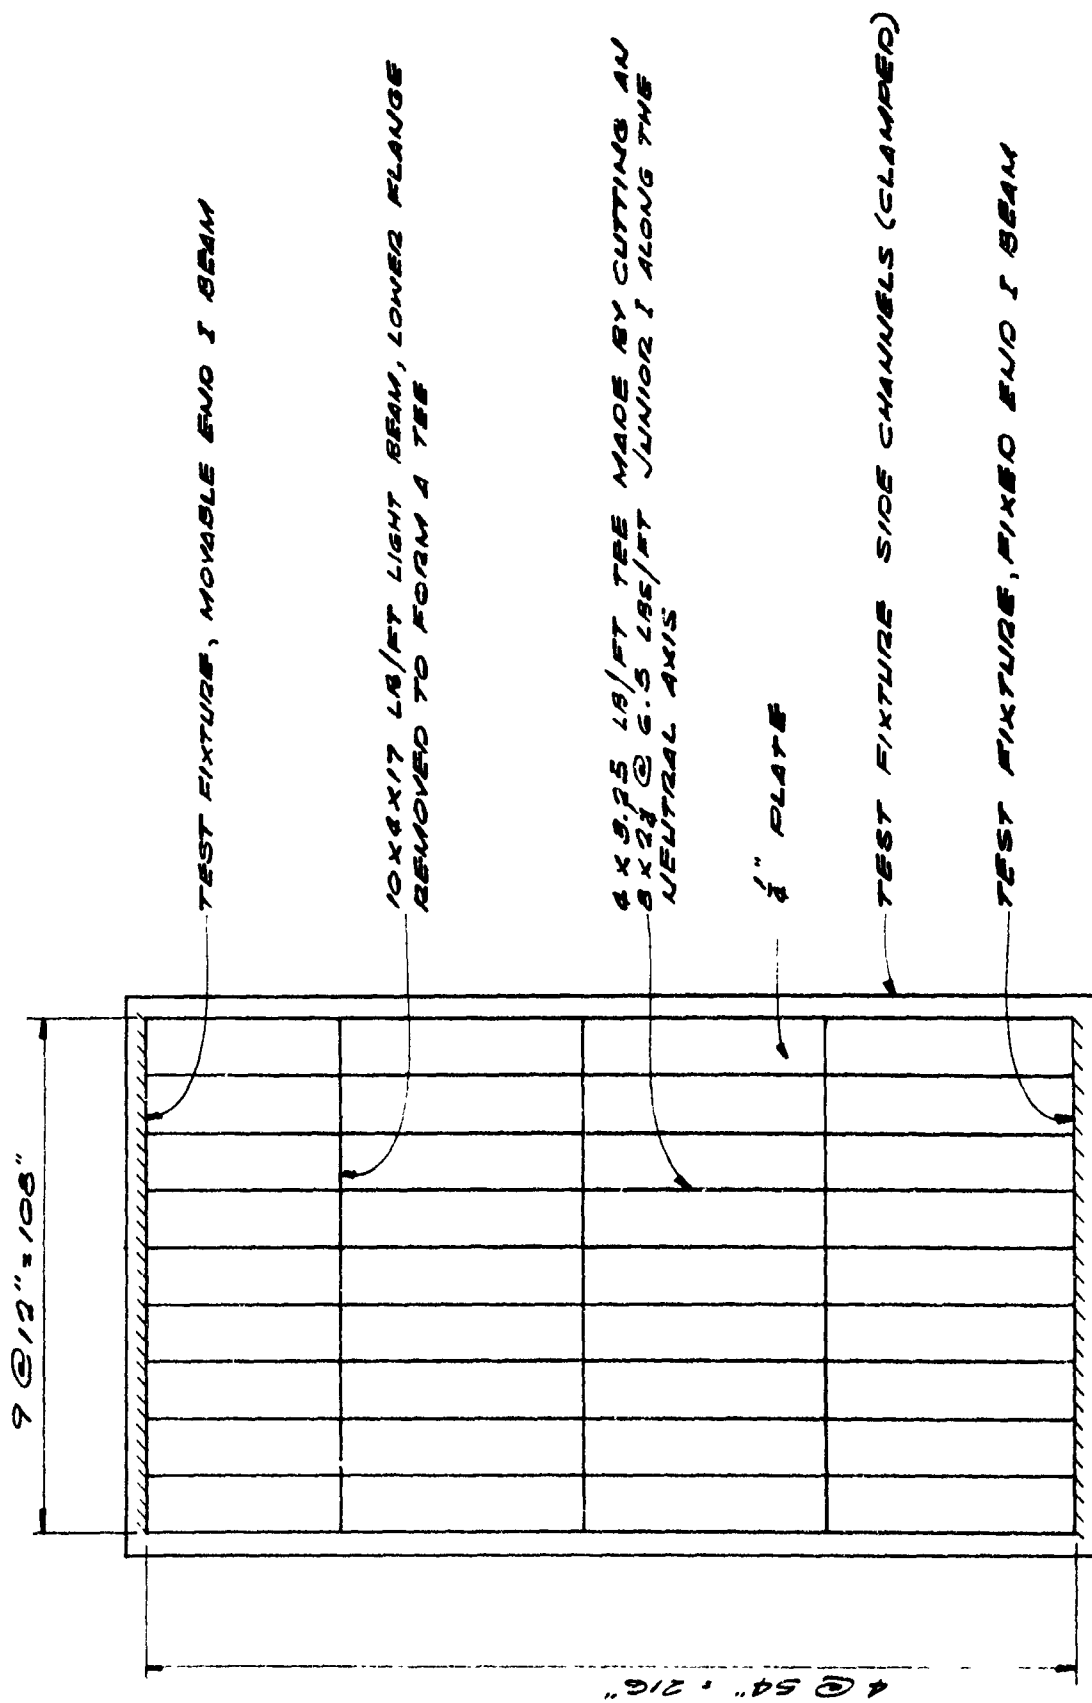
FIGURE 5. SKETCH OF GRILLAGE SPECIMEN

The grillage specimen tested was nominally the same in Tests 1(a), 1(b), and 1(c) and was as shown diagrammatically in the sketch of Figure 5.

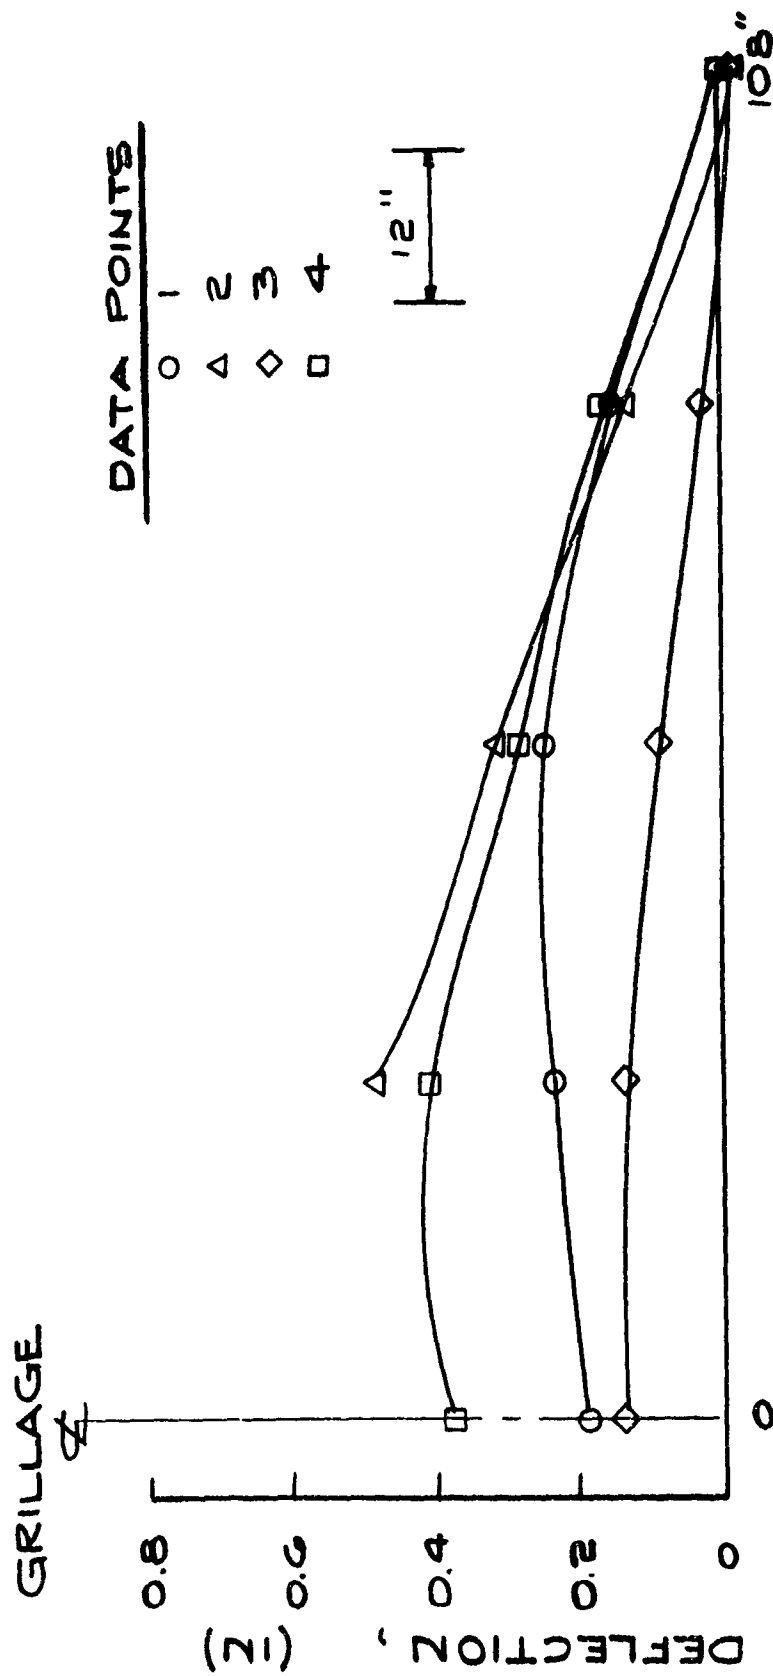
FIGURE 7(a). DEFLECTION OF THE GRILLAGE MEASURED ALONG LONGITUDINAL "B"

Test 1(a), the only completely instrumented test, had a total of 302 strain gages, plus several Ames dial gages, located as shown in Figure 6. During test, strain and deflection readings\* were taken for ten separate combinations of axial compressive stress and normal pressure which result from design curves currently in use at the Naval Ship Systems Command. These combinations are given in Table I where they are designated as Data Points. During the tests, each Data Point was obtained by first applying the axial load to the required value, then gradually increasing the normal pressure while holding the axial load constant. When the Data Point was reached, strain and deflection readings were taken and recorded. Also, in the case of Data Points 5, 6 and 7, intermediate readings were taken at values of  $1/3$  and  $2/3$  of the required normal pressure. As will be seen from Figure 4, deflection readings were obtained along one of the beams near the longitudinal centerline of the grillage and along the beam which forms the central transversal. The resultant readings are plotted in Figures 7(a) and (b).

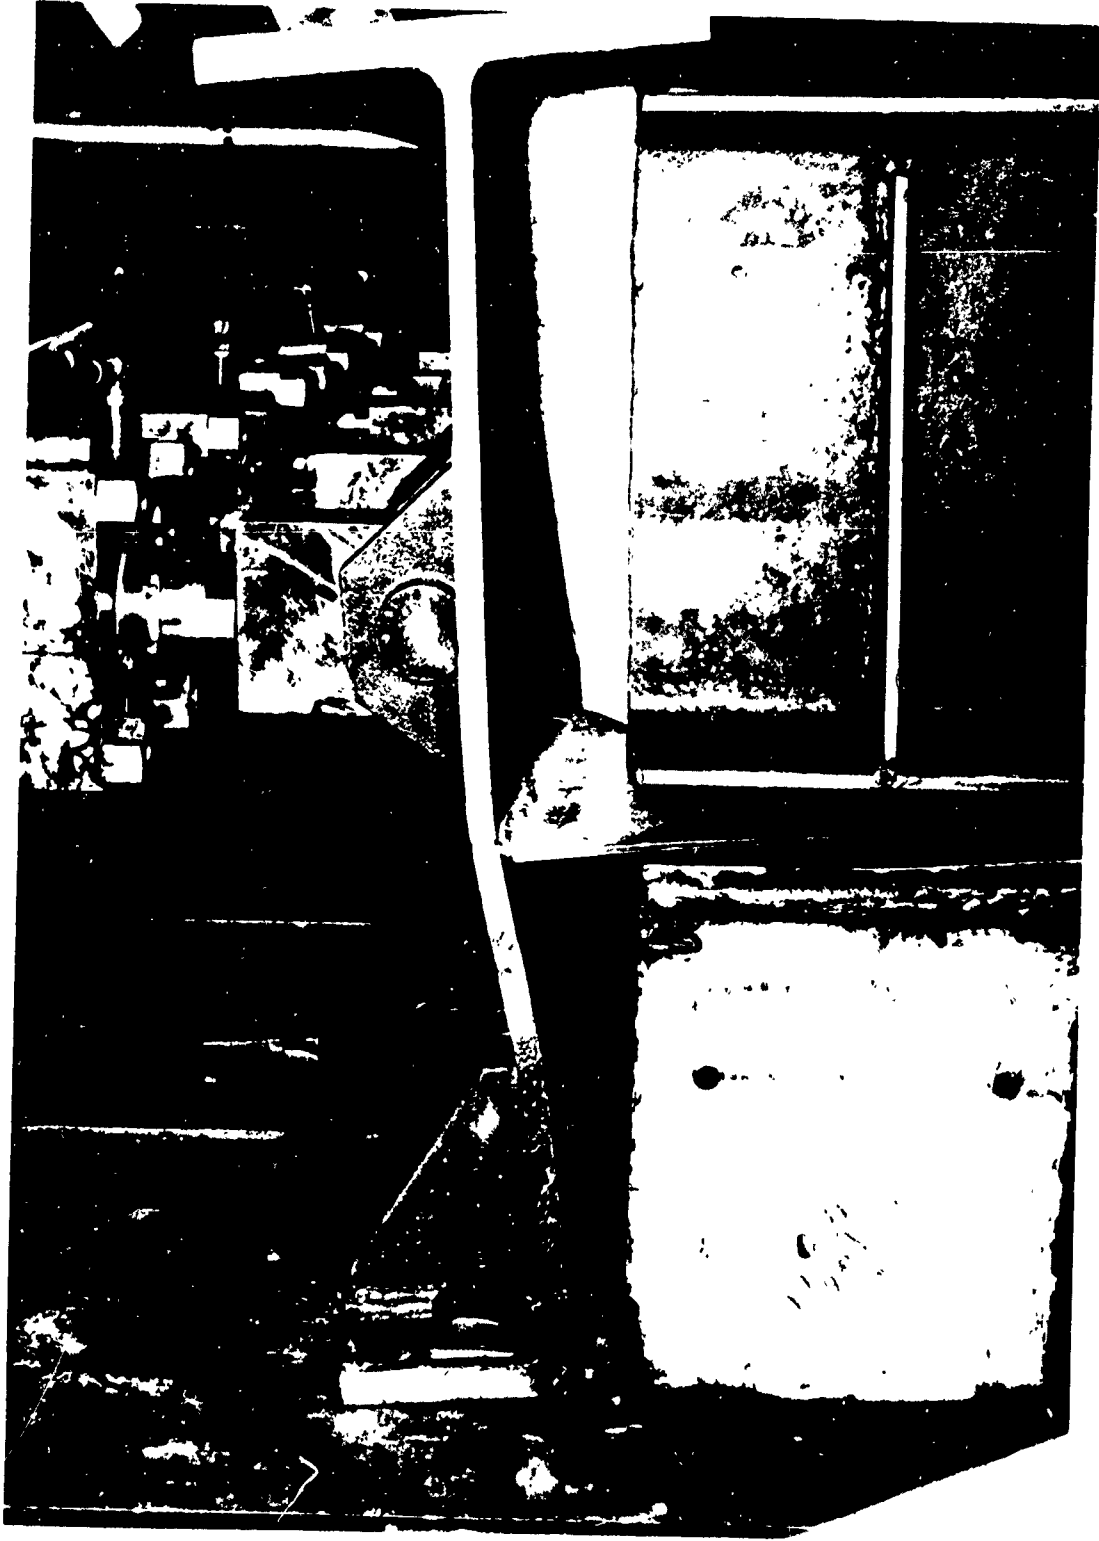
FIGURE 14. LOADING END AFTER TEST 1(c)

Examination of the grillage after test showed essentially the same features as in Test 1(b), namely a crippling of the stiffeners at the loaded end. An overall collapse of the grillage did not occur. At least in part, this was because of insufficient torsional rigidity within the heavy I-beam against which the jack pressure is applied. This beam, which is shown in Figure 14, bent and twisted so that the load was no longer applied at the center of gravity of the deformed section.

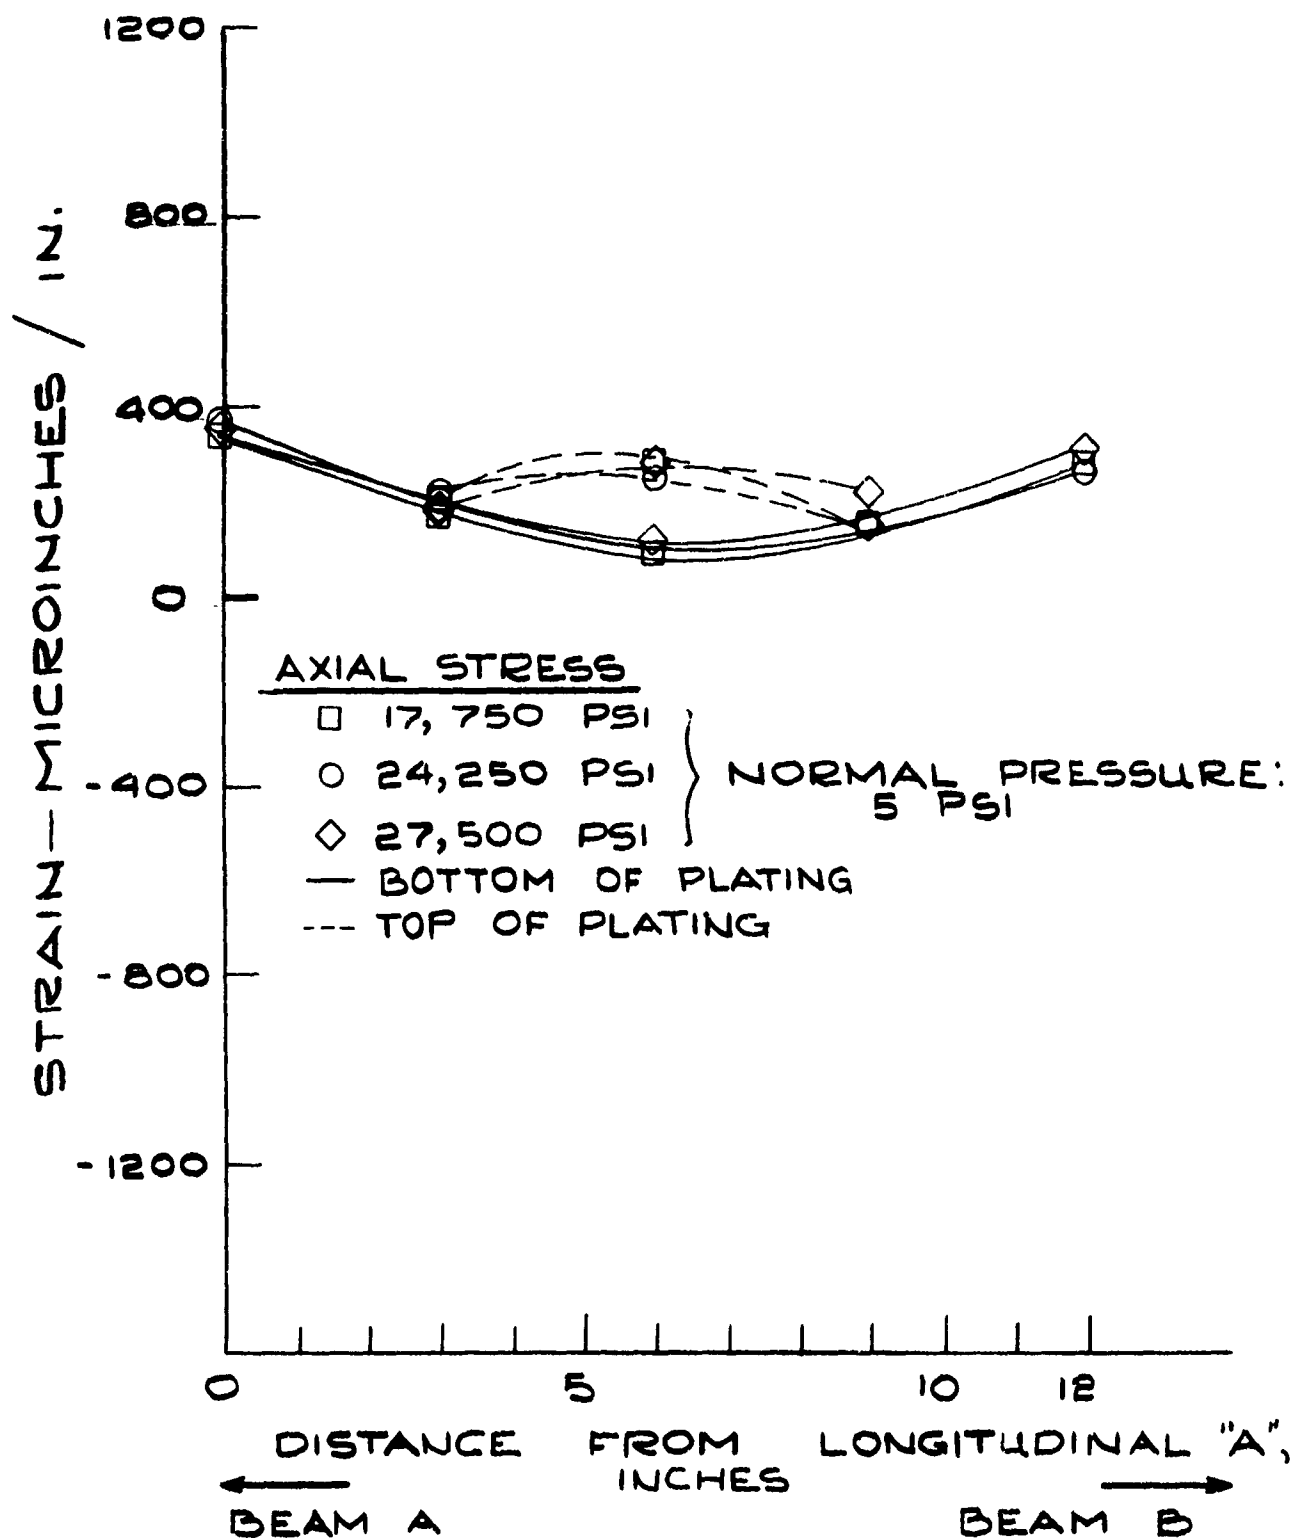
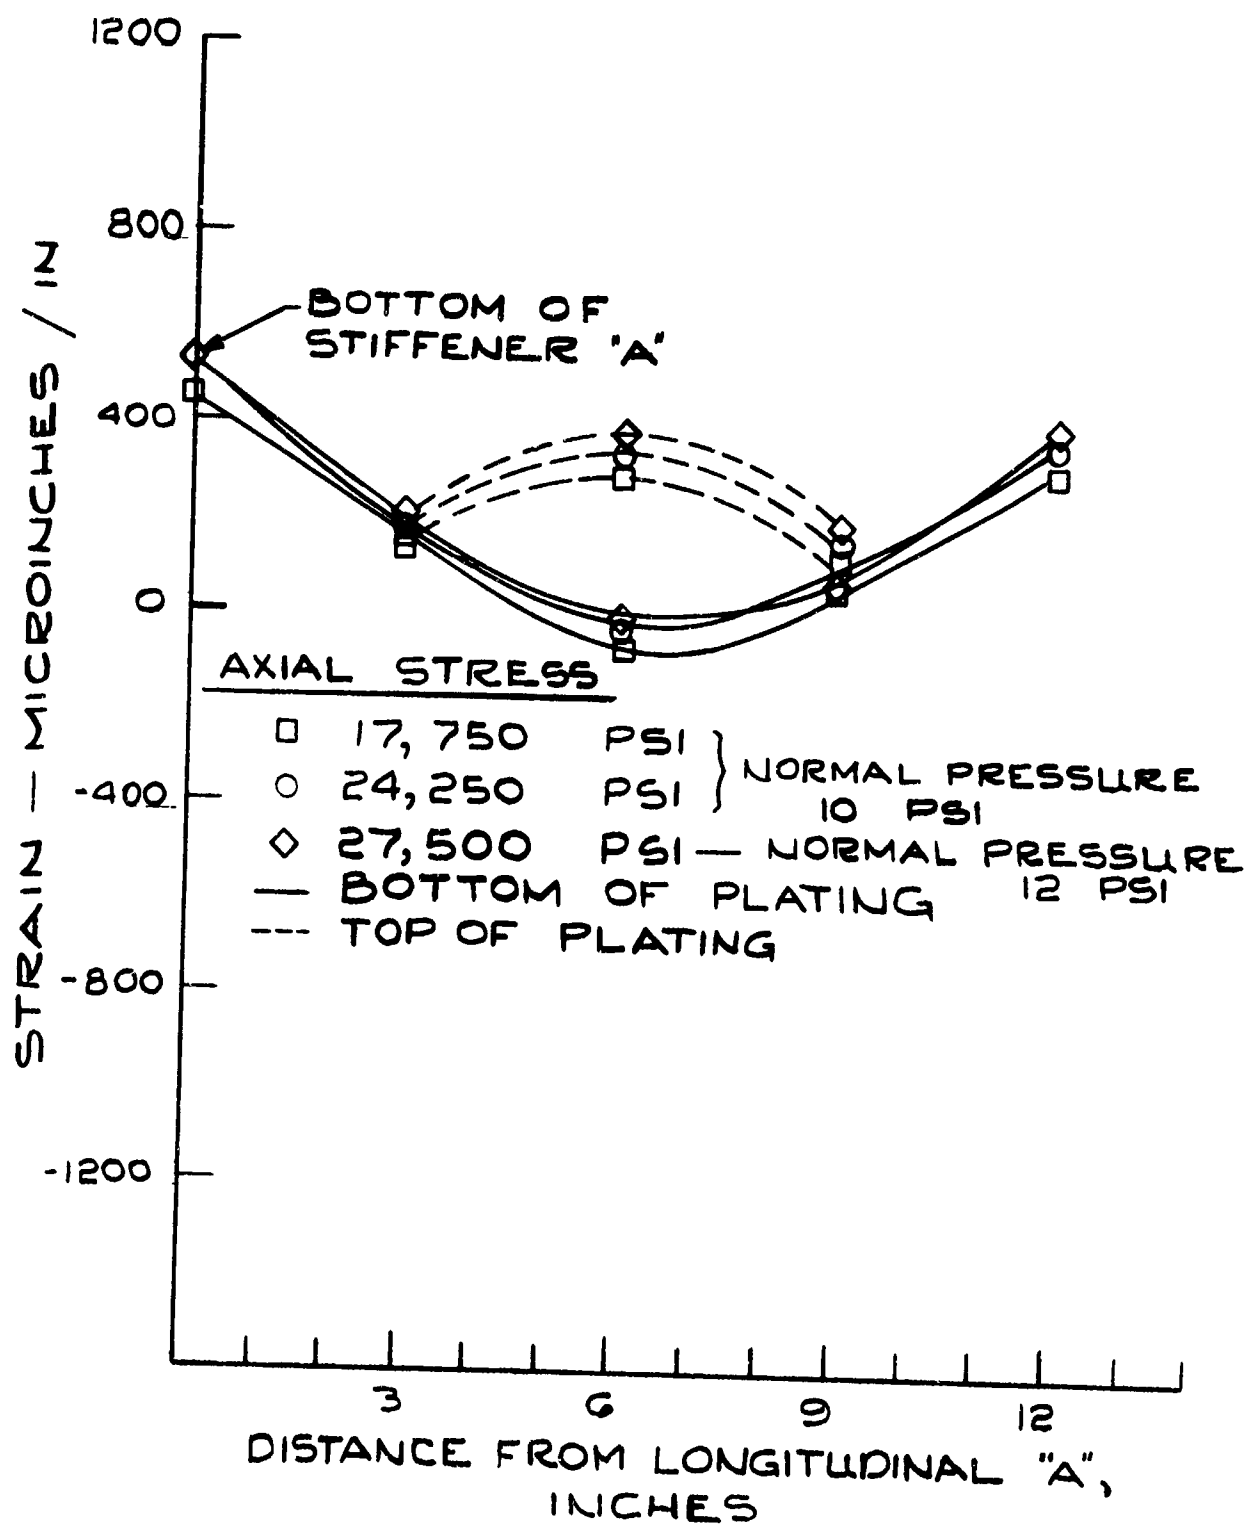
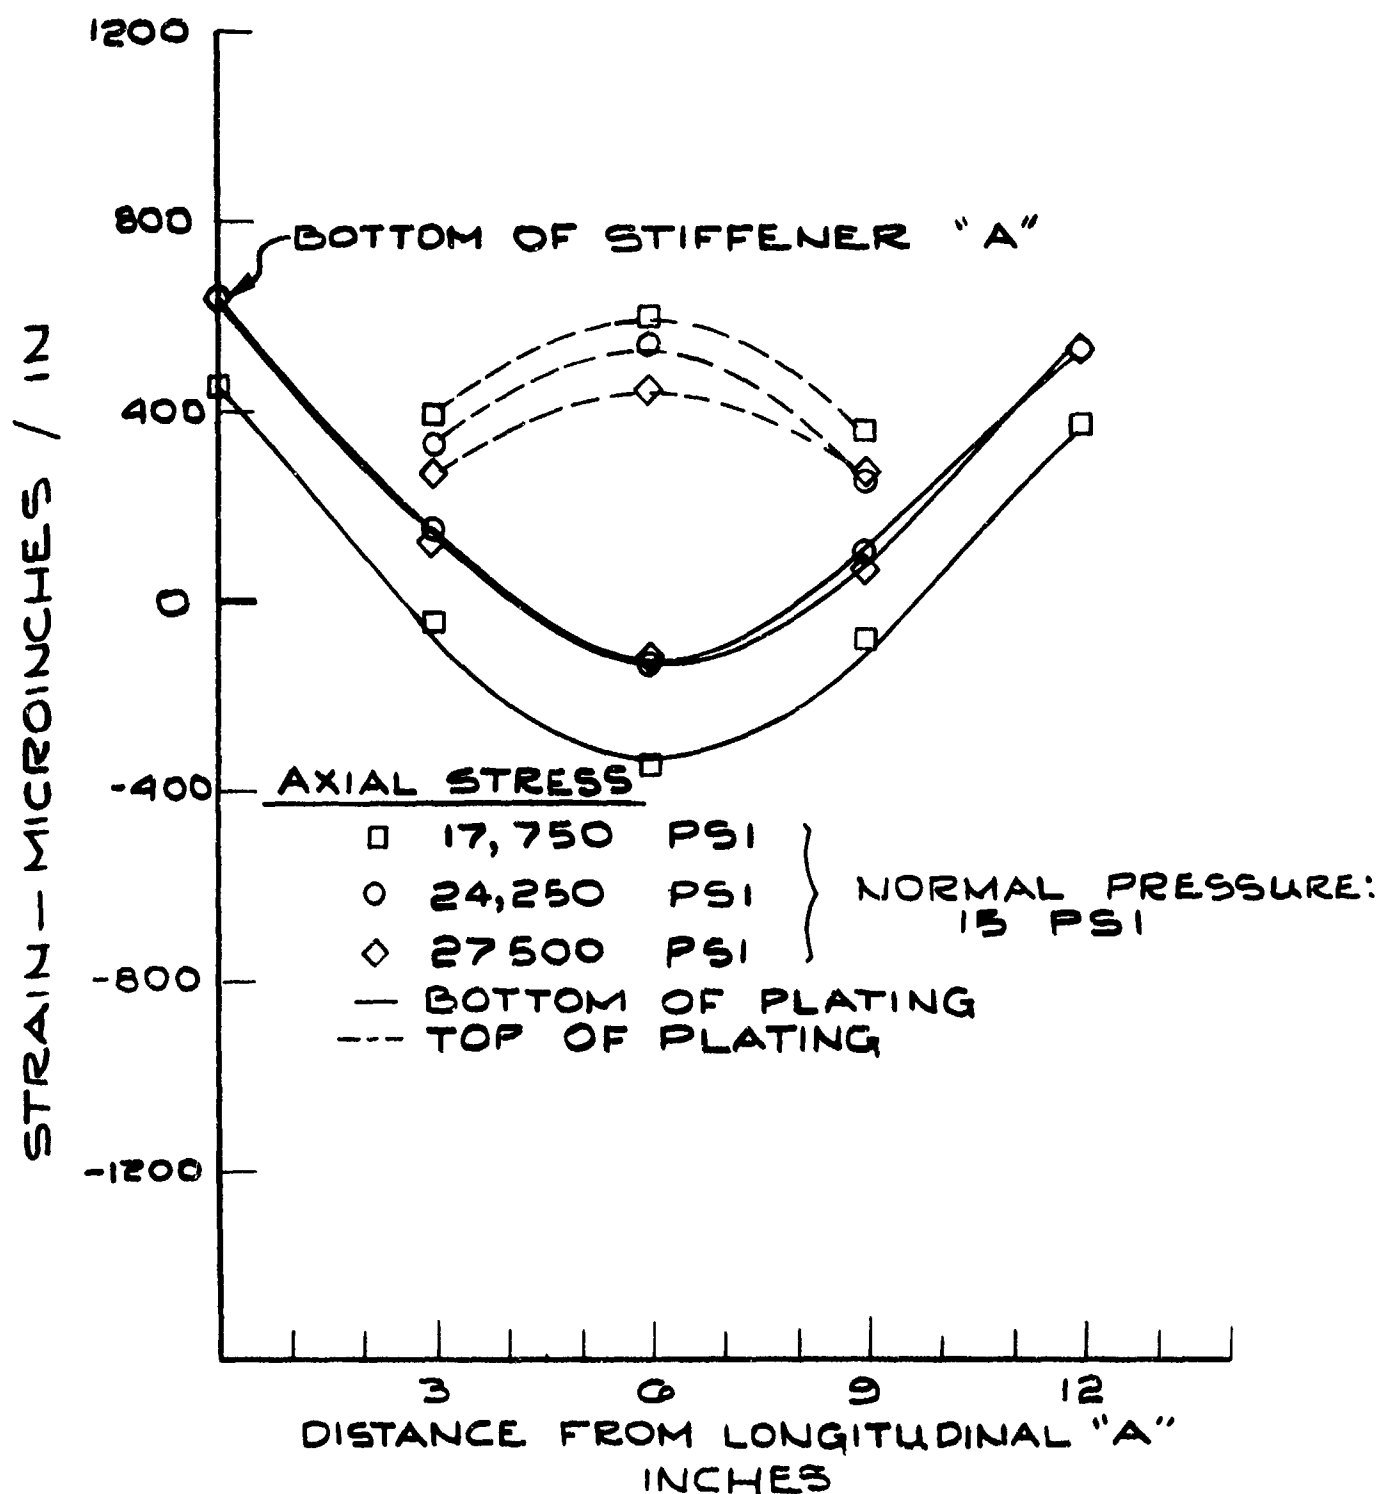
FIGURE 15. STRAIN,  $\epsilon_y$ , IN THE PLATING 27" FROM THE CENTRAL TRANSVERSAL

FIGURE 16. STRAIN,  $\epsilon_y$ , IN THE PLATING 27" FROM THE CENTRAL TRANSVERSAL

FIGURE 17. STRAIN,  $\epsilon_y$ , IN THE PLATING 27" FROM THE CENTRAL TRANSVERSAL

The foregoing statement is reinforced by examination of Figures 15, 16 and 17 which show plots of the  $\epsilon_y$  strains in the plating. The strains are always greater on the top surface than on the bottom and, when the pressure is low (5 psi), both sets of strains are positive; in contrast, for the higher pressures, the strains in the bottom become negative and the difference between the strains at the top and the bottom surfaces become greater with increasing normal pressure. These results can be shown to mean that, for the higher normal pressures, the plating bends to a cylindrical surface and at the lower pressures, there is a "membrane tension" in the plating in the transverse direction. This membrane action is reduced at the higher pressures because of the Poisson effect produced by the axial compressive load.

Figures 15, 16 and 17 show that  $\epsilon_y$  increases with normal pressure. This is to be expected because the plate has a strong curvature at the longitudinal stiffeners and the symmetry of the structure prevents rotation of the longitudinals; the panel, therefore, acts like a "fixed ended" plate.  $\epsilon_x$ , on the other hand, is practically unaffected by the normal pressure and as the preceding equation shows, as normal pressure is increased,  $\sigma_x$  in the plating is reduced. Since the total axial load does not change with increasing normal pressure, this can only mean that part of the axial load is transferred to the boundaries. This is very similar to the "effective width" phenomenon, long recognized in the post buckling behavior of plating. Therein, it has been found that the nature of the boundaries always plays an important part in the mechanisms of failure and must, therefore, be taken into account in an ensuing analysis.

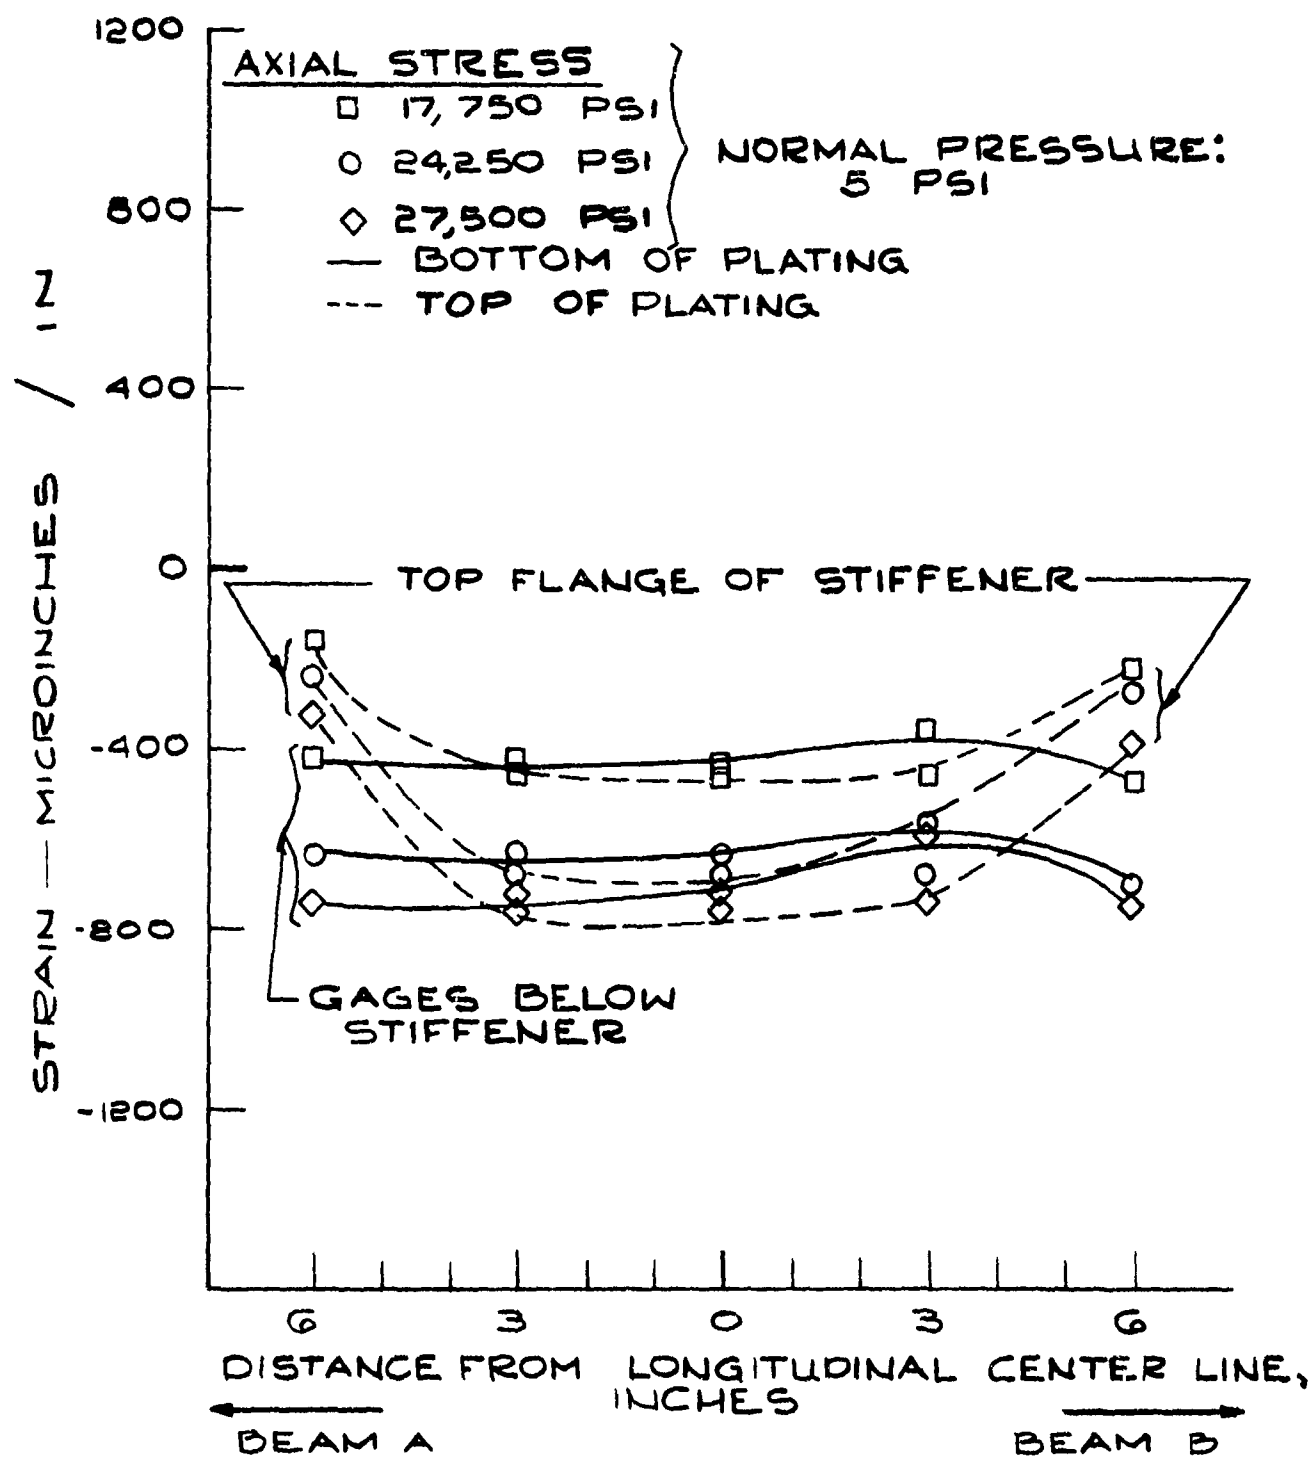
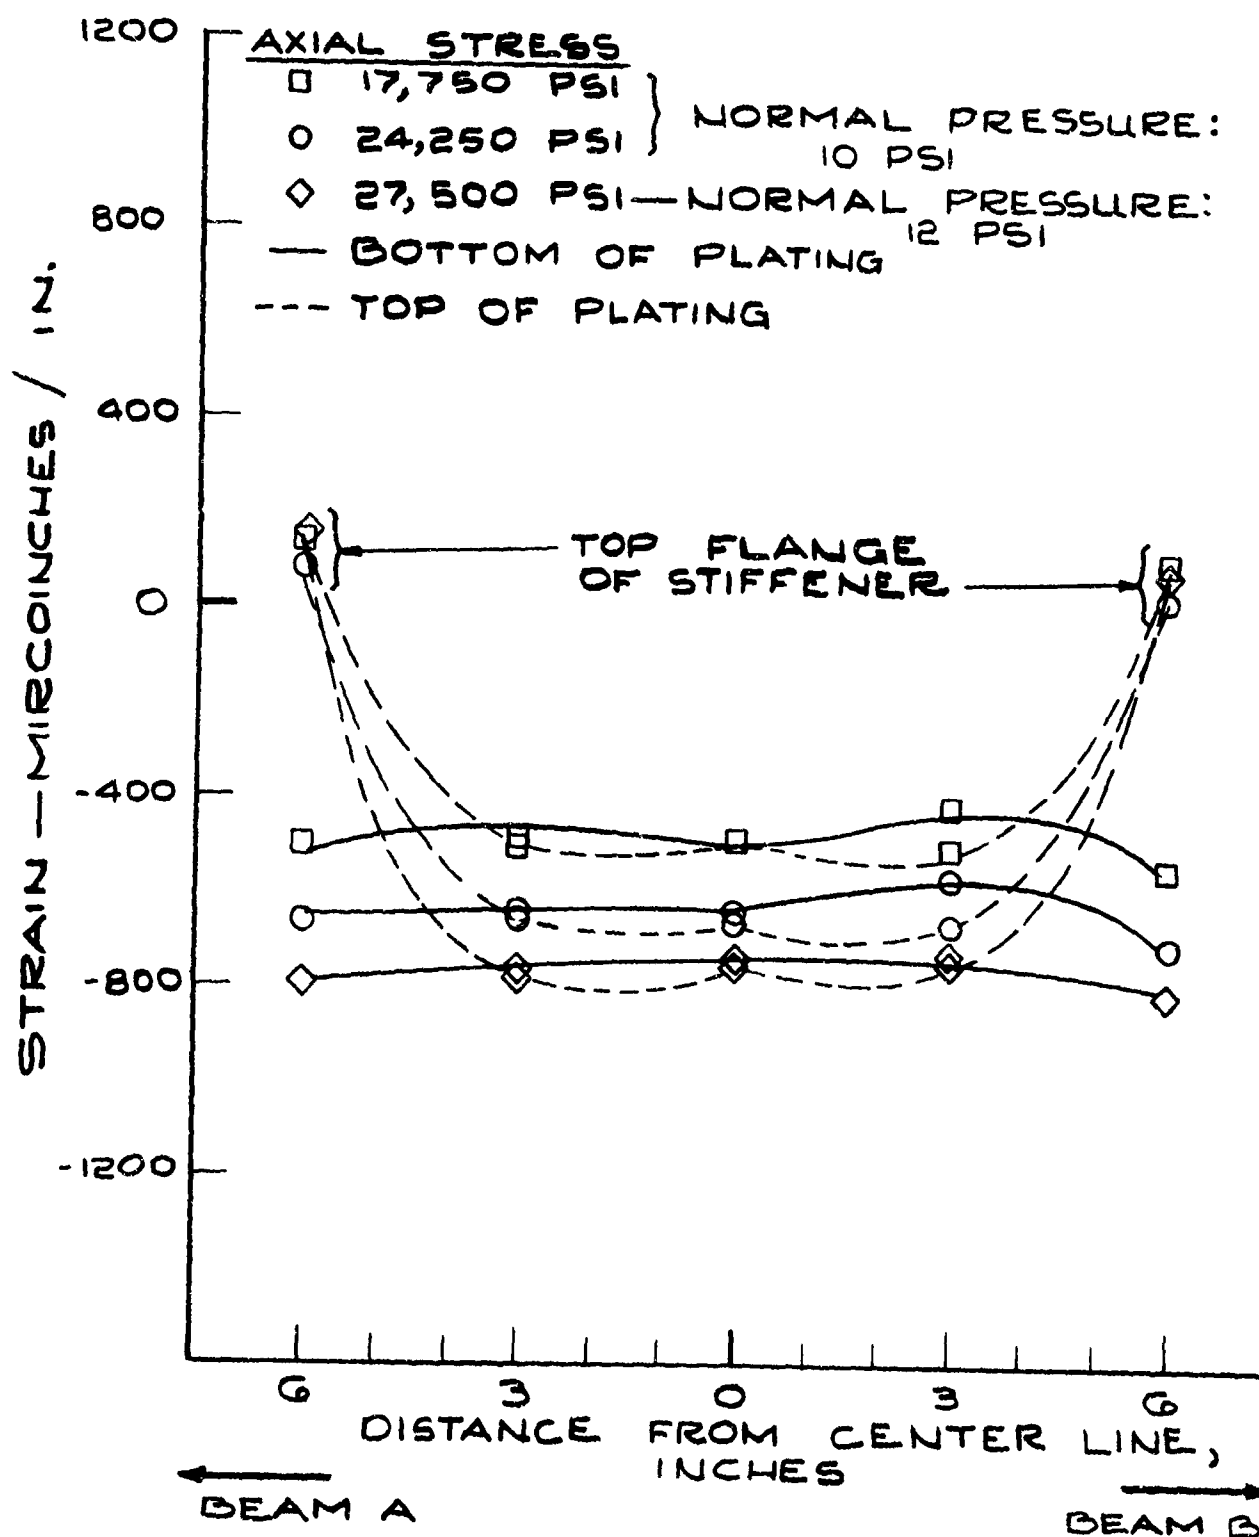
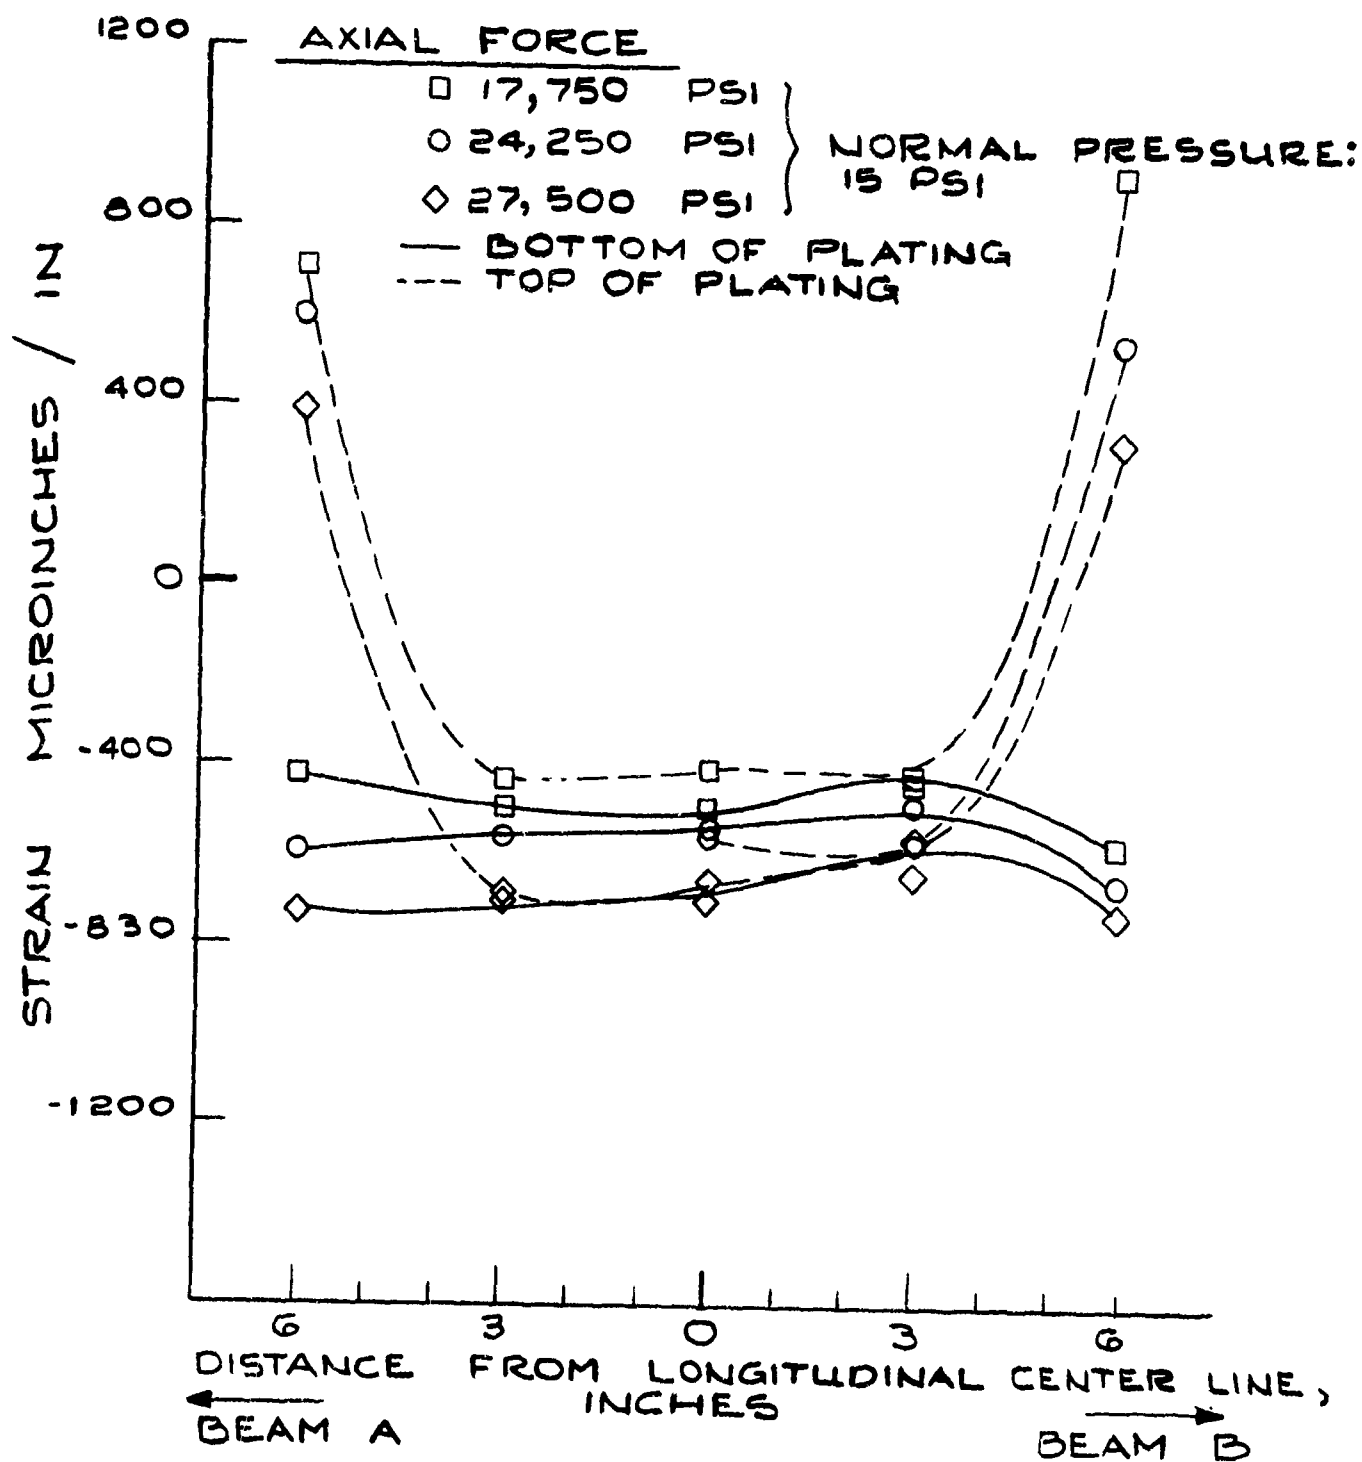
It will be seen from Figures 18, 19 and 20 that the longitudinal strain in the plating,  $\epsilon_x$ , is essentially uniformly distributed at all the combinations of axial force and normal pressure. The greatest deviations from uniformity are at the highest normal pressure of 15 psi. Furthermore, small and the magnitude does not change appreciably with normal pressure. It does change, however, with a change in axial pressure. This shows that: (a) the axial load is carried nearly uniformly by the plating and (b) the bending stresses in the longitudinal direction are small. These conclusions

FIGURE 18. LONGITUDINAL STRAIN,  $\epsilon_x$ , IN THE PLATING 27" FROM THE CENTRAL TRANSVERSAL

FIGURE 19. LONGITUDINAL STRAIN,  $\epsilon_x$ , IN THE PLATING 27" FROM THE CENTRAL TRANSVERSAL

FIGURE 20. LONGITUDINAL STRAIN,  $\epsilon_x$ , IN THE PLATING 27" FROM THE CENTRAL TRANSVERSAL

are in conformity with usual design assumptions, i. e. , that because of the panel aspect ratio, the plate undergoes "cylindrical bending. "

Consider Equation (5) which gives the membrane stress  $\sigma_y'$ . At 5 psi, Figure 14 shows that both  $\epsilon_y^T$  and  $\epsilon_y^B$  are positive; then from Figure 18,  $\epsilon_x^T$  and  $\epsilon_x^B$  are both negative. Thus, the membrane stress has a positive value for small pressures. As the normal pressure increases, however,  $\epsilon_y^B$  becomes negative (see Figures 16 and 17); therefore, although  $\epsilon_y^T + \epsilon_y^B$  still remain positive, the effect of the negative value of  $\mu(\epsilon_x^T + \epsilon_x^B)$  reduces the value of  $\sigma_y'$ . Also, this reduction increases for greater values of the axial compressive stress. As an example, at 5 psi normal pressure and 17,750 psi axial stress:

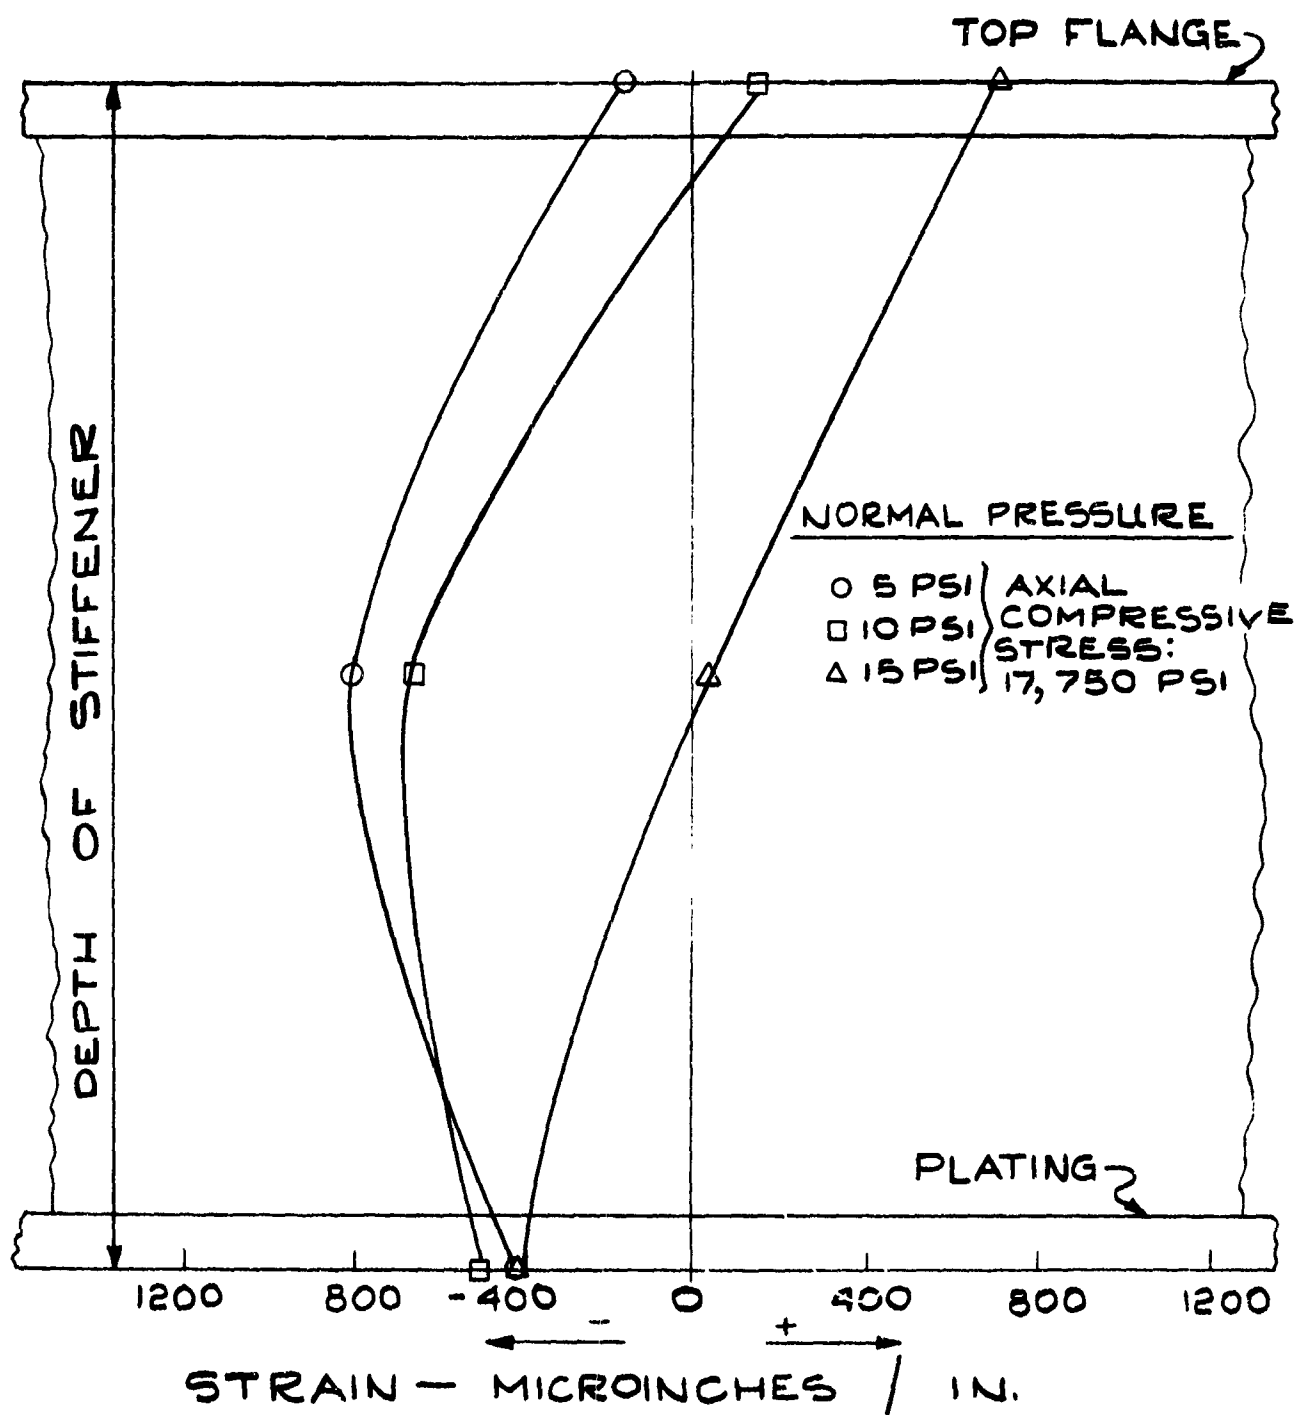
Figure 21 shows the strains in the longitudinal stiffener A at an axial compressive stress of 17,750 psi and various normal pressures. It may be noted that the strain distribution, while nonlinear at the lower pressures, approaches linearity at the highest normal pressure of 15 psi. The interesting feature is that, as the normal pressure increases, there is very little change in the bottom flange strain. This is not only because of the cylindrical bending of the panels previously noted but, also, because the "bottom flange" actually consists of an effective width of plating which

FIGURE 21. LONGITUDINAL STRAIN,  $\epsilon_x$ , IN THE LONGITUDINAL "A" 27" FROM THE CENTRAL TRANSVERSAL

provides a measure of lateral restraint. In contrast, the top flange strains change noticeably and the compressive strain in the web decreases rapidly with the increase of pressure.
